Case Study

Dislodged Manhole Cover

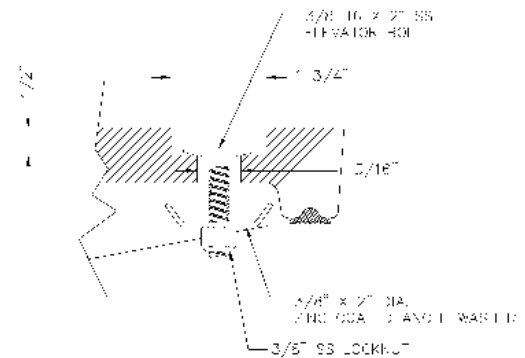
Cross section view of retrofit vent

- The manhole cover was an R-1772 manhole cover.
- Eight holes were drilled through the manhole cover and fitted with elevator bolts and angle washers.
- Positive pressure in the manhole causes the elevator bolts to rise allowing pressure dispersion to occur and thus prevent the manhole cover from coming dislodged.
- An angle washer and lock nut allow venting of the gas pressure while preventing the elevator bolt from being dislodged.

Neenah Foundry engineers worked with the City of Fort Wayne to design a modified manhole cover that could be retrofit into the existing frame.

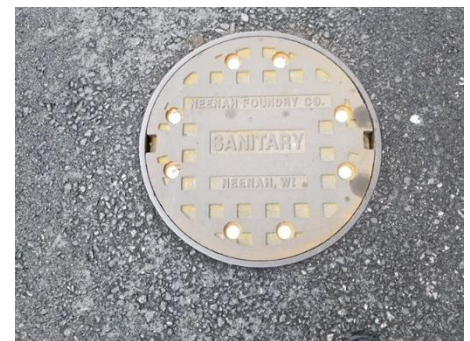
- The manhole covers are still in place and operating as designed.
- Retorfitting the manhole cover allowed for easy and fast replacement and reduced the need for more costly construction or system modifications.

Installed 1772 manhole cover with new venting (courtesy, City of Fort Wayne, IN)
